City of Doral

Canal Feasibility Study Report

REFERENCE: City of Doral Final Canal Feasibility Study Report

3.0 CANAL BANK EXISTING CONDITIONS ASSESSMENT

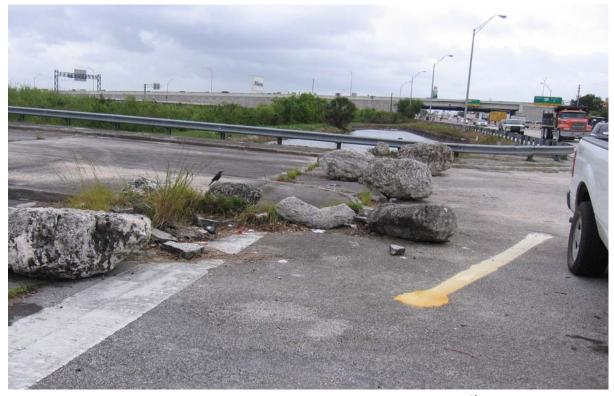
Photograph 1: (NORTHLINE CANAL) North side of NW 25th St at intersection with NW 78th Ave, facing east. Shows limestone boulders similar to that found along the canal banks throughout the area.

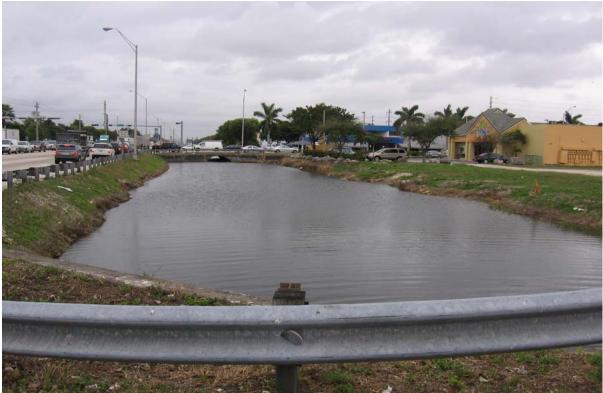
Photograph 2: (NORTHLINE CANAL) North side of NW 25th St at intersection with NW 78th Ave, facing west. Shows canal banks with gentle slopes and little erosion.

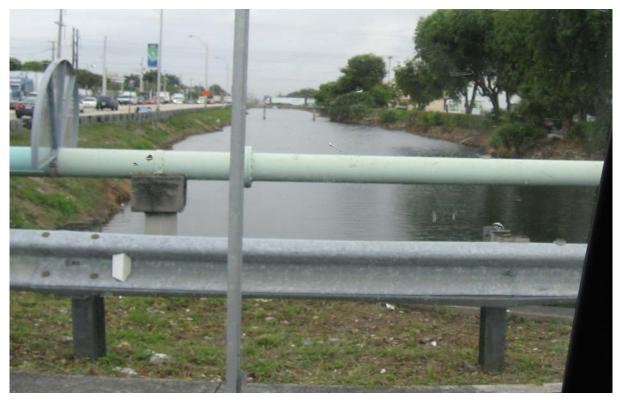
Photograph 3: (NORTHLINE CANAL) North side of NW 25th St at intersection with NW 79th Ave, facing west. Shows canal banks with moderate slopes and little erosion.

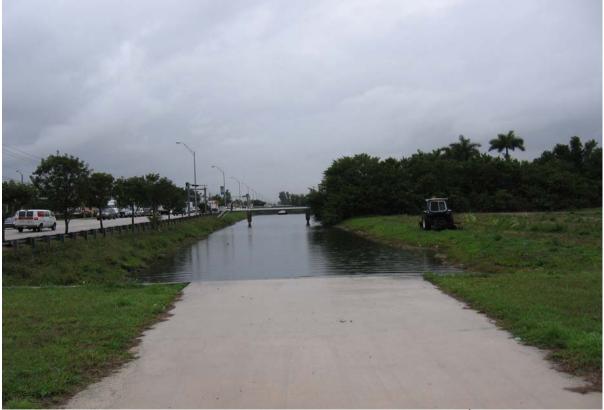
Photograph 6: (NORTHLINE CANAL) North side of NW 25th St at intersection with NW 27th St, facing west. Shows canal banks with moderate slopes and little erosion.

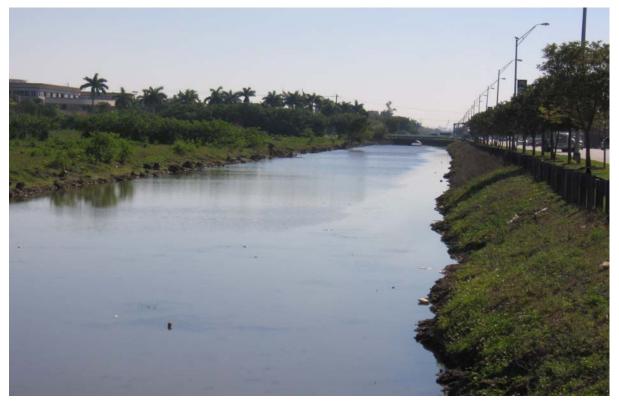
Photograph 7: (NORTHLINE CANAL) North side of NW 25th St at intersection with NW 94th Ave, facing east. Shows canal banks with gentle to moderate slopes and little erosion. Numerous boulders visible along northern canal bank.

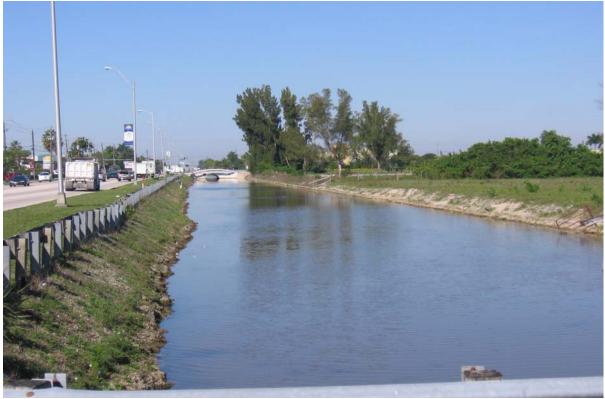
Photograph 8: (NORTHLINE CANAL) North side of NW 25th St at intersection with NW 94th Ave, facing west. Shows canal banks with moderate slopes and little erosion.

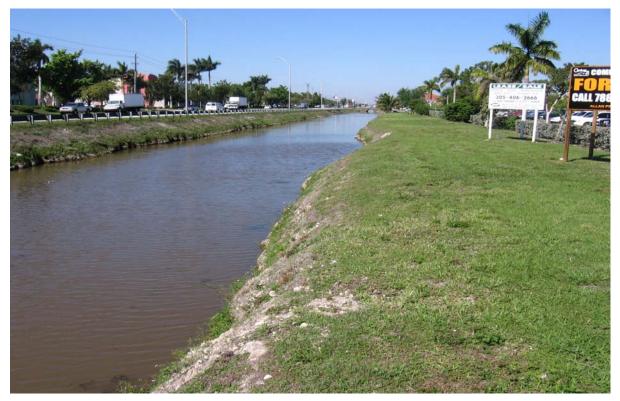
Photograph 9: (NORTHLINE CANAL) North side of NW 25th St at intersection with NW 97th Ave, facing west. Shows canal banks with steep slopes, moderate erosion and irregular canal width.

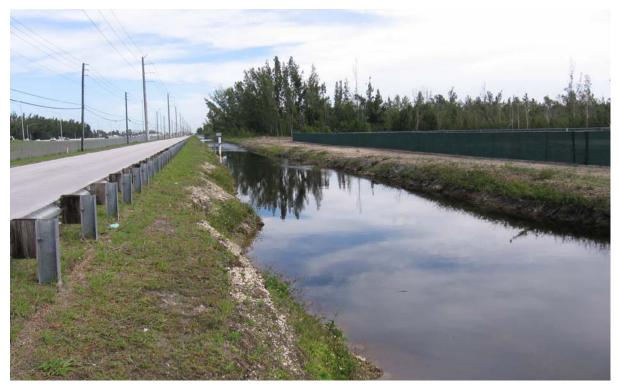
Photograph 11: (C-2 EXTENSION) East side of NW 117th Ave just north of NW 25th St, facing north. Shows canal banks with moderate to steep slopes, moderate to severe erosion and irregular canal width.

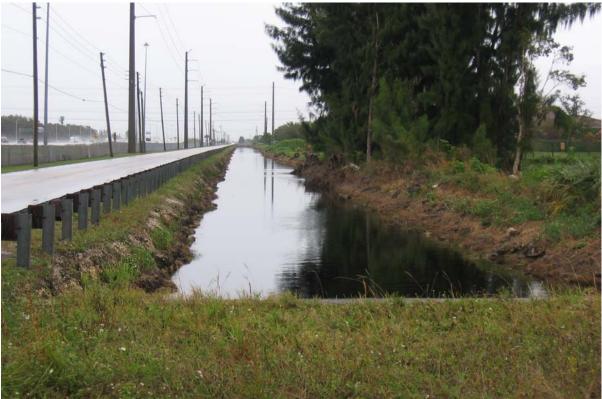
Photograph 15: (C-2 EXTENSION) East side of NW 117th Ave just north of Doral Blvd, facing north. Shows canal banks with moderate to steep slopes and moderate erosion.

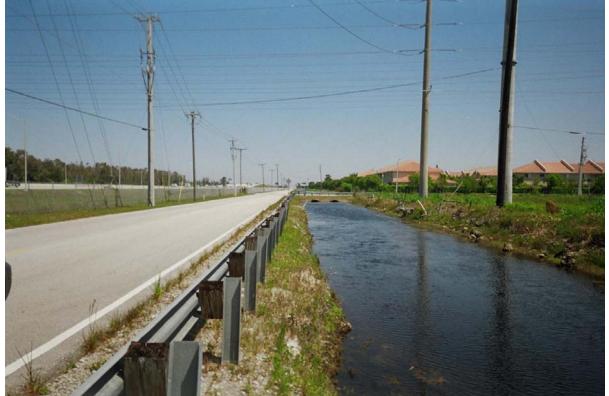
Photograph 16: (C-2 EXTENSION) Viewing north along west canal bank, shows moderate to steep canal slopes with moderate erosion, little horizontal distance between guard railing and top of bank.

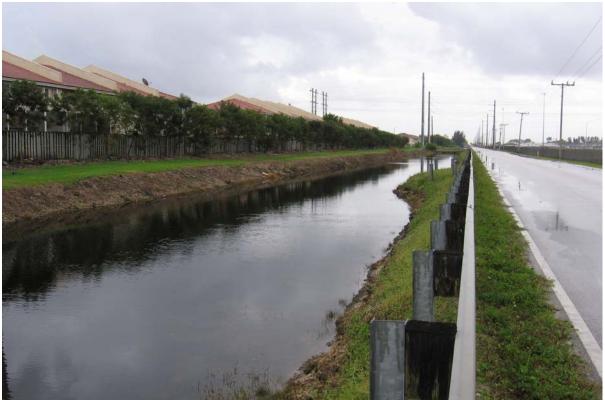
Photograph 17: (C-2 EXTENSION) East side of NW 117th Ave just north of NW 50th St, facing south. Shows canal banks with moderate to steep slopes and moderate erosion.

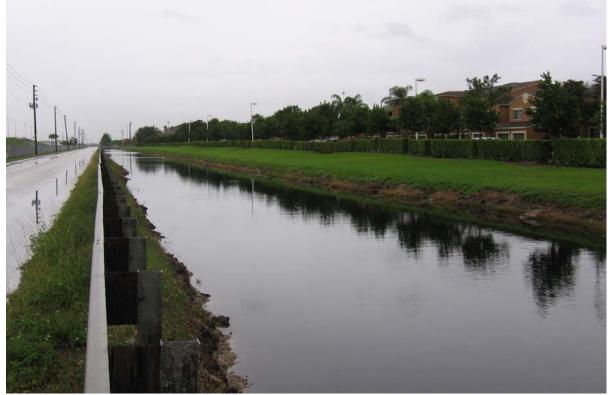
Photograph 18: (C-2 EXTENSION) East side of NW 117th Ave just north of NW 50th St, facing north. Shows canal banks with moderate to steep slopes and little to moderate erosion.

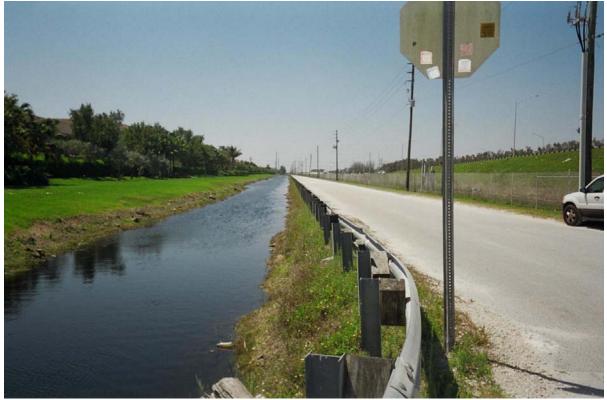
Photograph 19: (C-2 EXTENSION) Viewing south along west canal bank, shows moderate to steep canal slopes with moderate erosion, little horizontal distance between guard railing and top of bank.

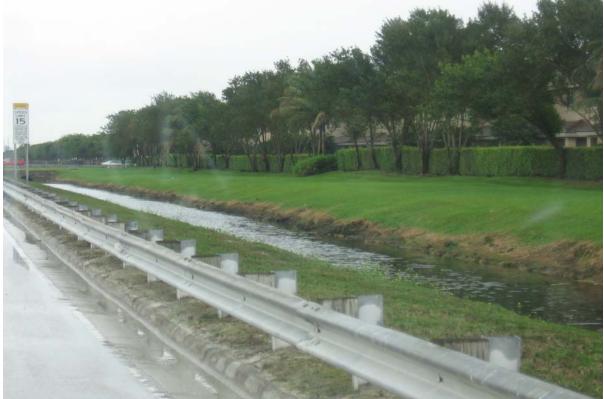
Photograph 20: (DRESSELS CANAL) South side of NW 58th St just east of NW 112th Ave, facing southwest. Shows canal banks with moderate slopes and little to moderate erosion.

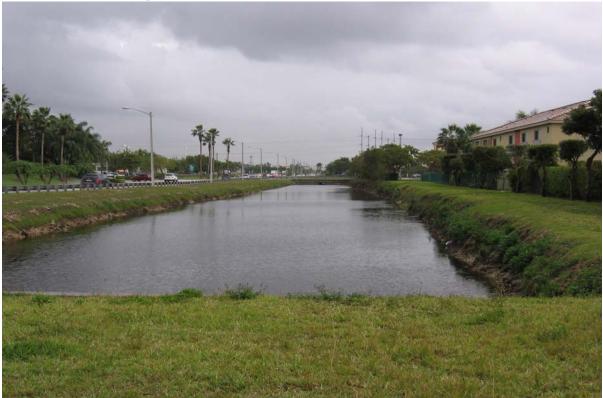
Photograph 22: (DRESSELS CANAL) NW 109th Ave at intersection with NW 58th St, facing east. Shows canal banks with moderate to steep slopes and moderate erosion.

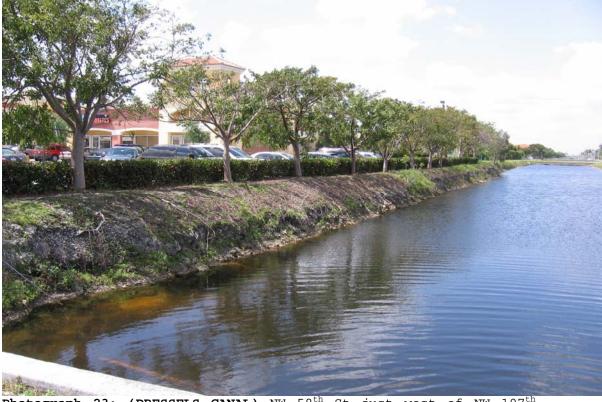
Photograph 23: (DRESSELS CANAL) NW 58th St just west of NW 107th Ave, facing west. Showing steep slopes and severe erosion on south canal bank (adjacent to "Delia Plaza").

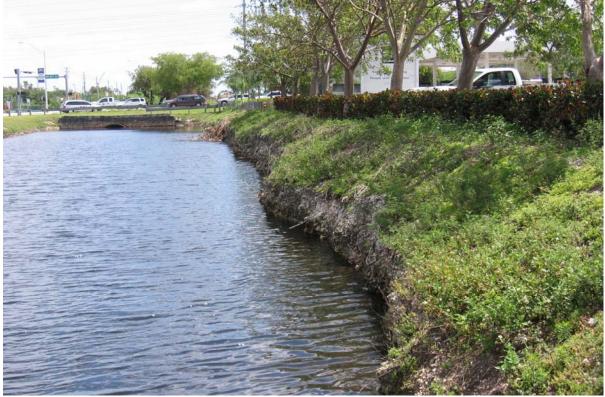
Photograph 24: (DRESSELS CANAL) NW 58th St just west of NW 107th Ave, facing east. Showing steep slopes and severe erosion on south canal bank (adjacent to "Delia Plaza").

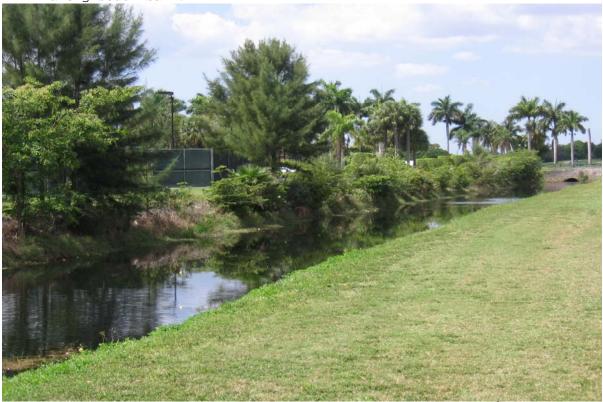
Photograph 26: (DRESSELS CANAL) Canal section between NW 104th Ave and NW 102nd Ave, facing southwest. Showing heavy overgrowth along south bank.

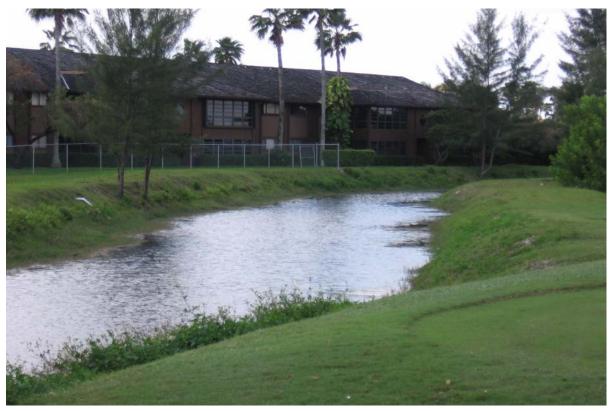
Photograph 27: (DRESSELS CANAL) Canal crossing at NW 102nd Ave, facing west. Showing steep, grass-covered slopes with little erosion.

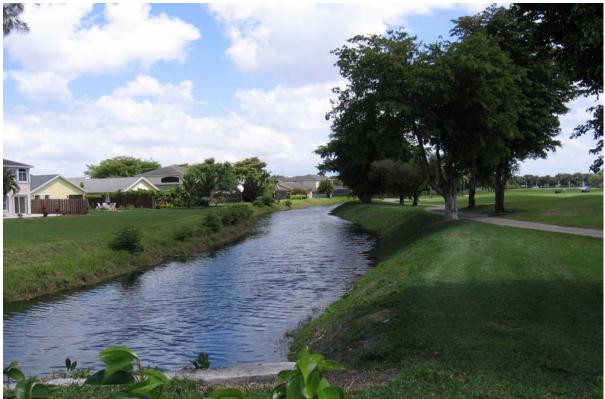
Photograph 28: (DRESSELS CANAL) Canal crossing at NW 102nd Ave, facing east. Showing moderate to steep grass-covered slopes with little erosion.

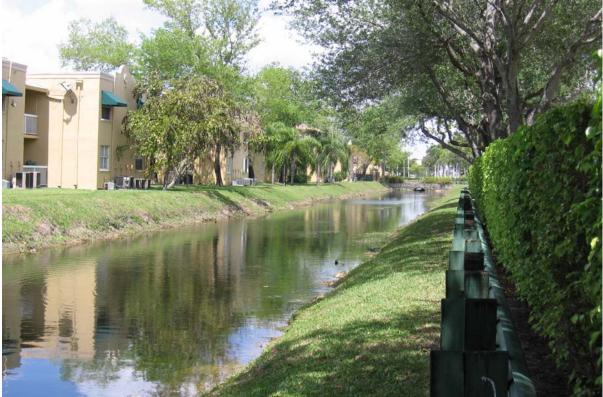
Photograph 29: (DRESSELS CANAL) West side of NW 97th Ave just south of NW 49th Ter, facing north. Showing moderate grass-covered slopes with little erosion.

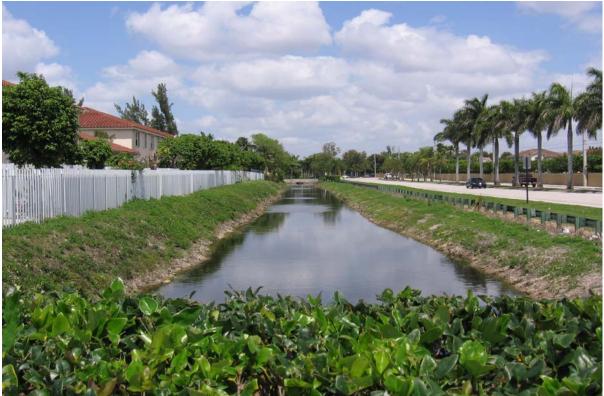
Photograph 30: (DRESSELS CANAL) West side of NW 97th Ave just south of NW 45th Ln, facing north. Showing moderate grass-covered slopes with little erosion.

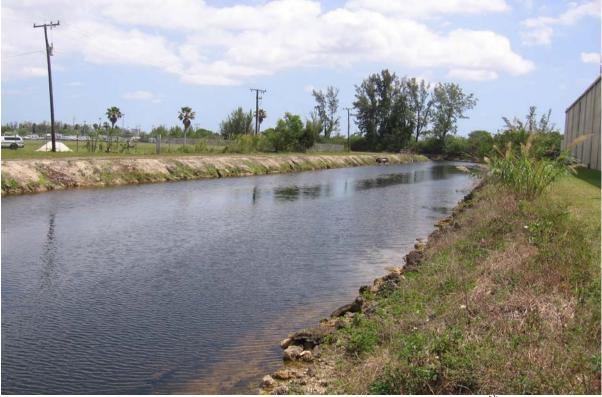
Photograph 31: (DRESSELS CANAL) Canal section along NW 40th St, showing moderate slopes and little to moderate erosion. Also numerous boulders along west bank.

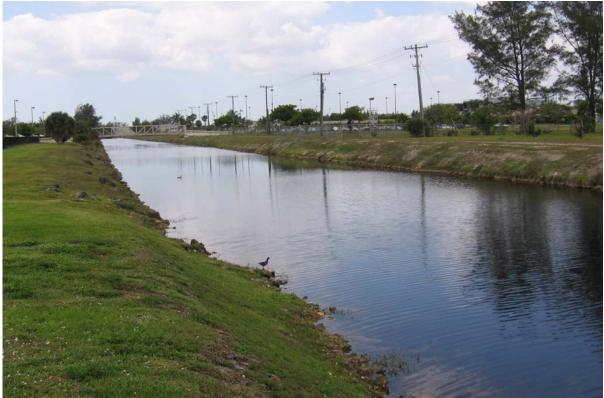
Photograph 33: (DRESSELS CANAL) Canal section just south of Federal Reserve (Doral Blvd), facing west. Showing moderate slopes and little erosion. Numerous boulders visible along south bank.
