City of Doral

Canal Feasibility Study Report

REFERENCE: City of Doral Final Canal Feasibility Study Report

3.0 CANAL BANK EXISTING CONDITIONS ASSESSMENT

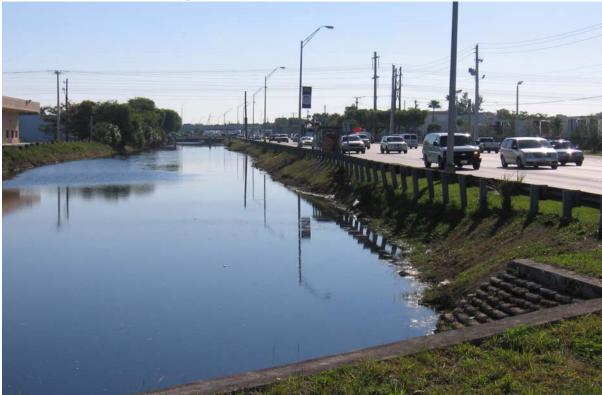
Photograph 4: (NORTHLINE CANAL) North side of NW 25th St at intersection with NW 82nd Ave, facing east. Shows canal banks with steep slopes and severe erosion. Guardrail is rotating towards canal.

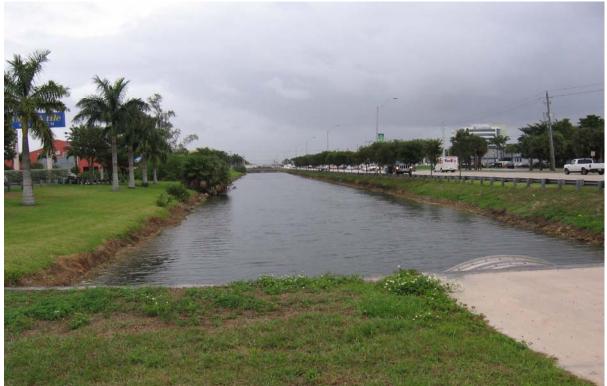
Photograph 5: (NORTHLINE CANAL) North side of NW 25th St at intersection with NW 27th St, facing east. Shows canal banks with gentle to moderate slopes and little erosion.

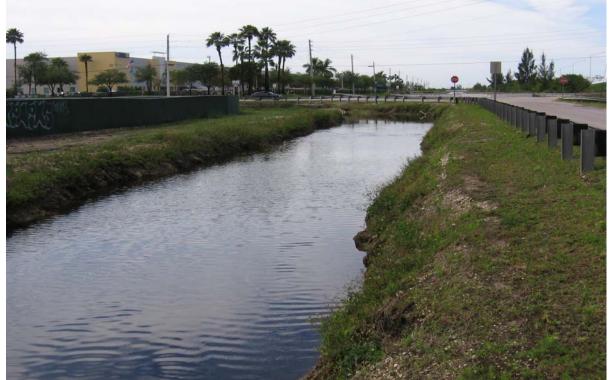
Photograph 10: (C-2 EXTENSION) East side of NW 117th Ave just north of NW 25th St, facing south. Shows canal banks with moderate to steep slopes, moderate to severe erosion and irregular canal width.

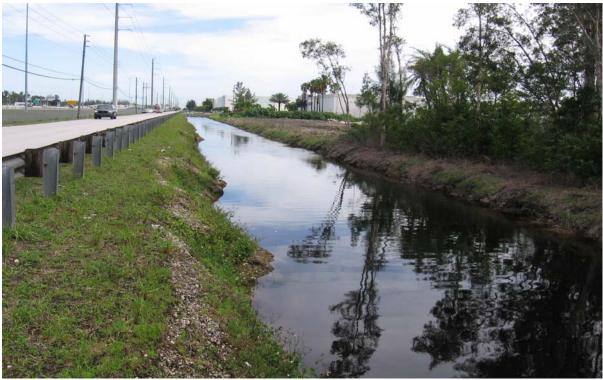
Photograph 12: (C-2 EXTENSION) East side of NW 117th Ave just south
 of NW 34th St, facing north. Shows canal banks with moderate
 to steep slopes, moderate to severe erosion and irregular
 canal width.

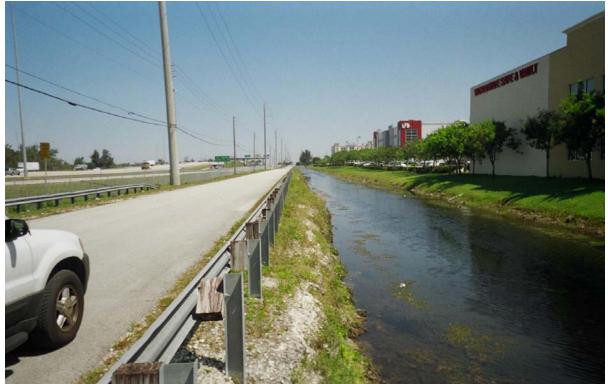
Photograph 13: (C-2 EXTENSION) Viewing north along west canal bank, shows moderate to steep canal slopes with moderate erosion, little horizontal distance between guard railing and top of bank.

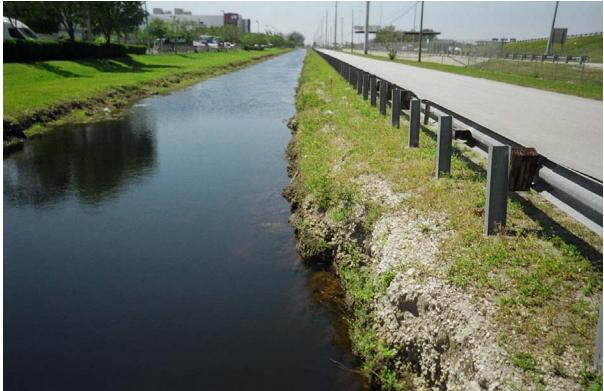
Photograph 14: (C-2 EXTENSION) Viewing south along west canal bank, shows moderate to steep canal slopes with moderate erosion, little horizontal distance between guard railing and top of bank.

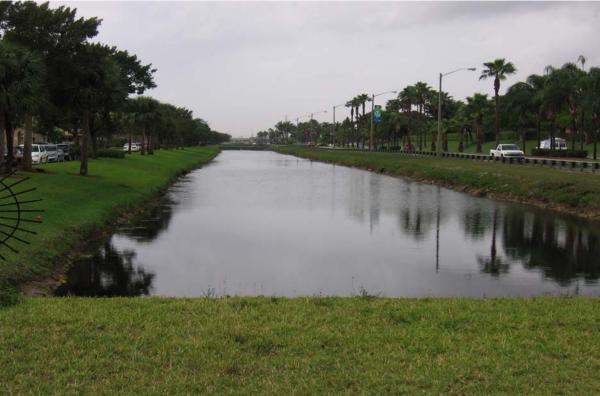
Photograph 21: (DRESSELS CANAL) NW 109th Ave at intersection with NW 58th St, facing west. Shows canal banks with gentle to moderate slopes and little to moderate erosion.

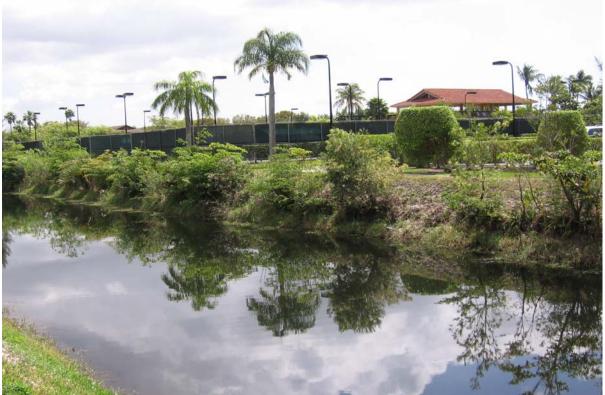
Photograph 25: (DRESSELS CANAL) Canal section between NW 104th Ave and NW 102nd Ave, facing southeast. Showing heavy overgrowth along south bank.

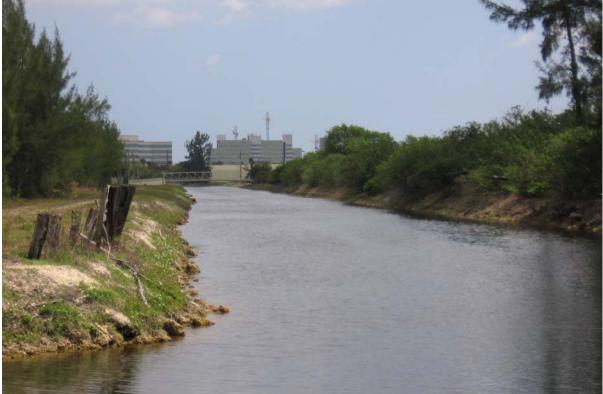
Photograph 32: (DRESSELS CANAL) Canal section along NW 40th St, facing east. Showing moderate slopes and little to moderate erosion.

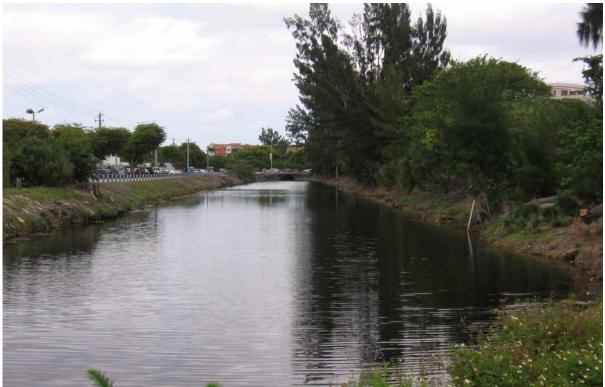
Photograph 34: (DRESSELS CANAL) Canal section just south of Federal Reserve (Doral Blvd), facing northeast. Showing moderate slopes and little erosion.

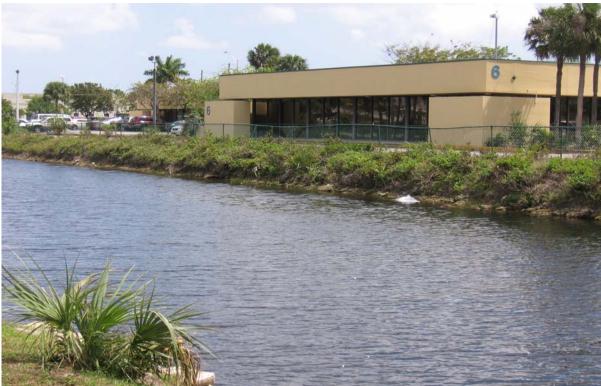
Photograph 35: (DRESSELS CANAL) NW 41st St just west of NW 79th Ave, facing southeast. Showing moderate to severe erosion and heavy overgrowth.
